## Reliability Testing of Medical Electronic Circuits using IST

**Bill Birch**

**President PWB Interconnect Solutions**

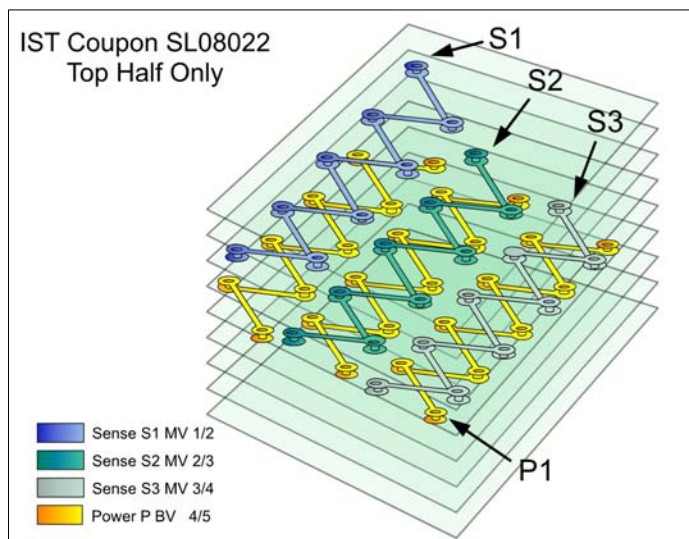
## Case Study – Design SL08022

- *The coupon is an SL08022 – four circuits*
- *The power circuit P is a buried via on layer 4/5*
- *The sense circuit S1 is microvias on layers 1/2 and 7/8*
- *The sense circuit S2 is microvias on layers 2/3 and 6/7*
- *The sense circuit S3 is microvias on layers 3/4 and 5/5*
- *This coupon is tested at 210°C*
- *This coupon does not have capacitance circuits*

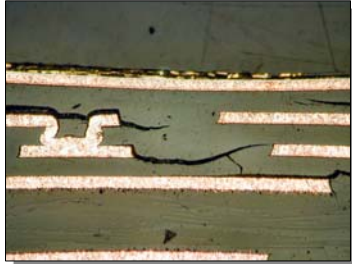
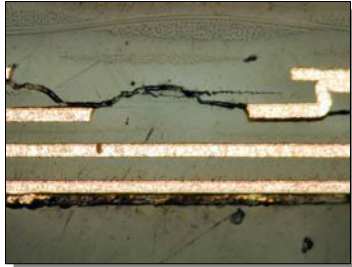
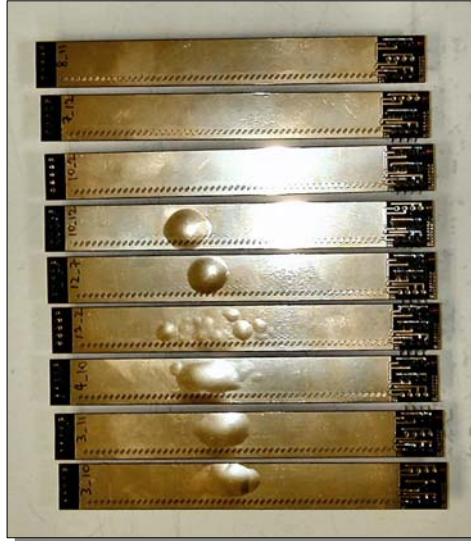
## Case Study – Fabricator 2

- *The second fabricator had one failure out of 10 coupons*
- *There was delamination in 6 coupons*

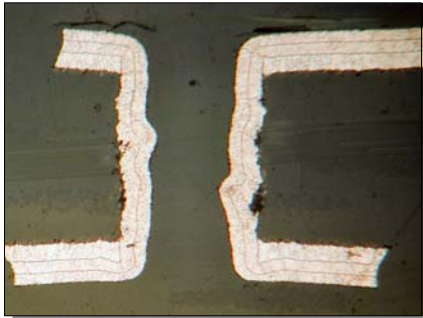
## Case Study – Fabricator 3

- The third fabricator had 18 power circuit failures out of 18 coupons – mean cycles to failure 112
- There was no delamination

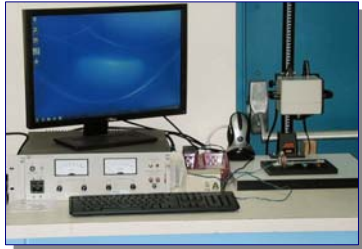
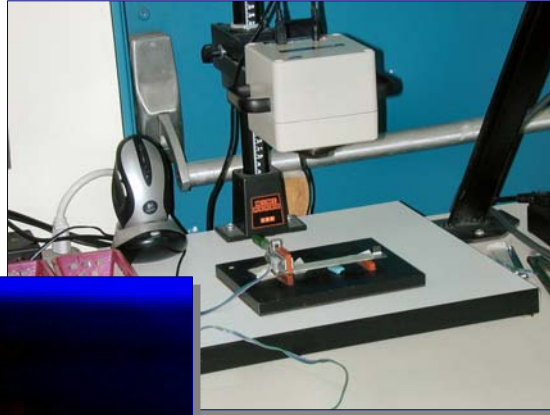
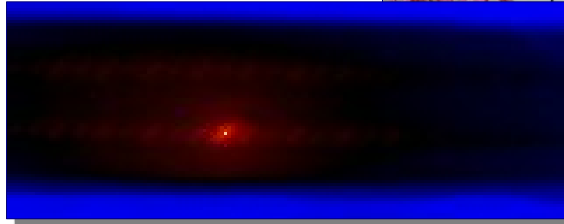
## Failure Location

- *Testing Stops at 10% Increase in Resistance*
- *The Failed Circuit is not Open*
- *The Failed Circuit can be Heated with a Small Amount of Current*
- *While Being Heated the Failed Circuit is Observed with a Thermal Camera*
- *The Most Damaged Circuits Shows as a Hot Spot*
- *Thermo-graphic Camera allows the Identification of the Most Damaged Interconnection*

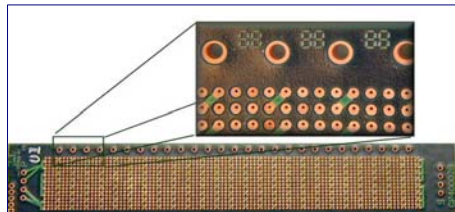
## Capacitance Measurement

- *IST Coupon Design Critical to Measurement Sensitivity*
- *Validation of Product Construction / Material Dk*
- *Measurements Taken Before & After IST Thermal Cycles*
- *Changes in Capacitance Signify Delamination*
- *Capability Confirmed, Test Protocol Established/Available*

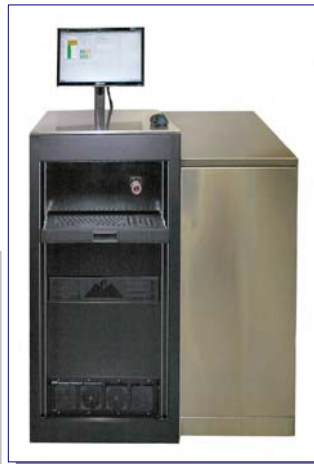
## IST Equipment

- *Hardware - IST Testing Machine*
  - *Eight Individually Controlled Test Heads*
  - *Automated – Preconditioning and Testing*
  - *Requires Clean, Controlled Environment*
- *Software*
  - *Automated Control of Heating and Cooling*
  - *Continuous Measurements of Environment and Product*
  - *Automated Report Generation*
  - *Automatic Safety Controls (Watch Dog, Emergency Shutoff)*

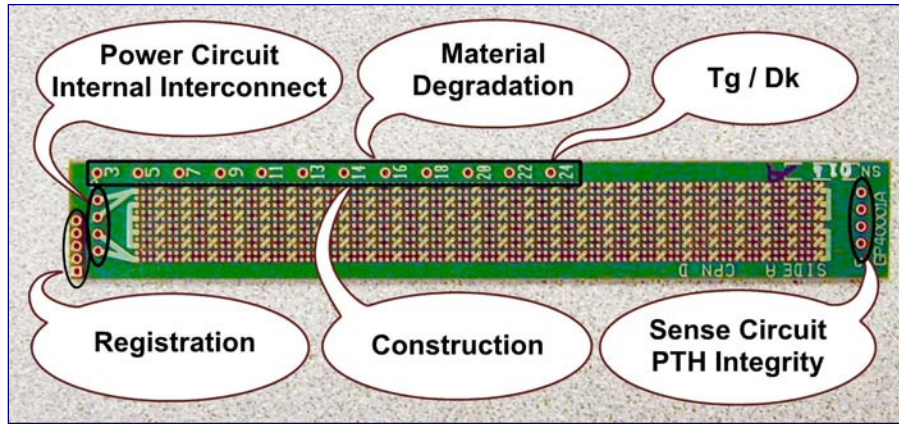
## Test Coupon

- *The Line width is the One Variable that is adjustable by IST Design*
  - *Line Width is Determined by IST Coupon Design Requirements*
  - *Power Circuit Line widths are Adjusted to Assure the Resistances are Optimized for Heating Efficiency*
  - *The Sense Circuit Line Widths are Adjusted to Assure the Maximum Sensitivity*

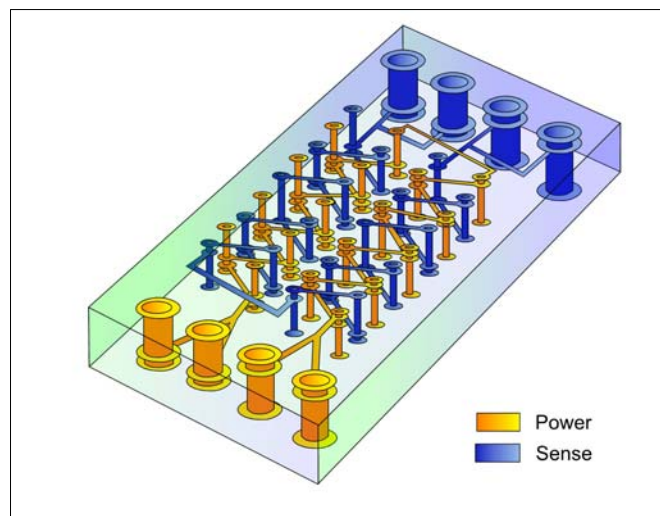
## Test Coupon

- *The Coupon Must Reflect the Critical Attributes of the PWB*
  - *Coupon Reflects Thickness and Layer Count*
  - *Copper Weights used in the Construction*
  - *Holes Sizes that includes the Smallest Hole Size*
  - *Surface Finish that is Appropriate*
  - *Grid size*
  - *Construction*
  - *Designs are Required for Each Level of Technology*
- *All Above is Established by the Customers Requirements*

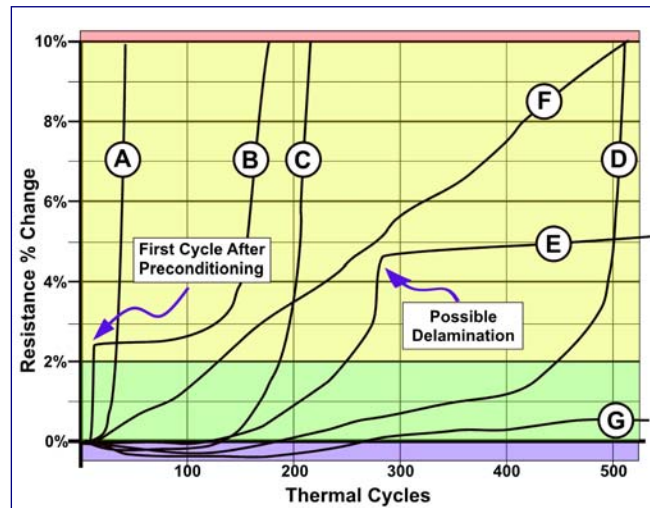
## Plot of Damage Accumulation

- *Plot of Damage Accumulation at 150°C*
- *Resistance at Temperature for Each Cycle*
- *Damage is caused by cracks in copper*
- *Damage is Express as Increase in Resistance*
- *A 10% Increase is a Failure = Top of Graph*
- *Review – Onset, Slope, Acceleration etc.*
- *Sense Circuit Shows Typical Wear Out*
- *Power Circuits Shows Typical Acceleration*
